WELDING INSPECTION REPORT

Resident Engineer: Pursell, Gary **Report No:** WIR-014766 Address: 333 Burma Road **Date Inspected:** 07-Jun-2010

Project Name: SAS Superstructure **OSM Arrival Time:** 700 **OSM Departure Time:** 1900 **Prime Contractor:** American Bridge/Fluor Enterprises, a JV

34-0006 Tower **Bridge No: Component:**

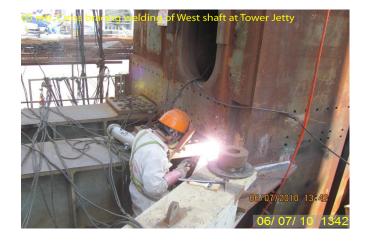
1. This QA inspector, Baskar Govindarajan, observed, ZPMC qualified welding personnel identified as 056364 perform SMAW Buttering welding on; North shaft, Lift 5 in the cut edges and the weld joint identified as NSD1-STSA5-3B-F-40A. ZPMC CWI Identified as Mr. Xu Le Feng. The welding parameters as measured using QC's calibrated instruments appeared to be in general compliance with WPS-485-SMAW-2G (2F)-Repair.(Photo attached)
